Visual Inspection of Historical Buildings Using Micro UAV

Masiri Kaamin^{1*}, Noor Azyyati Idris², Saifullizan Mohd Bukari², Zaurin Ali², Norhafiza Samion¹, and Mustaffa Anjang Ahmad²

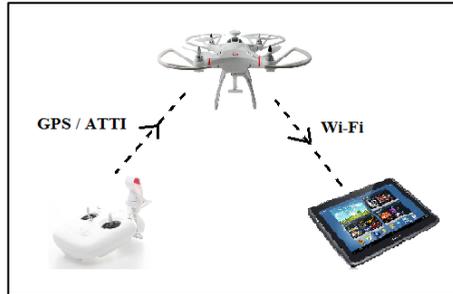
Fig. 1. Connection between remote control, DJI Phantom FC40 & smartphone.

Fig. 1 shows the UAV that has been used in this research. DJI Phantom FC40 is equipped with camera for recording image or videos. The recording will display through the smart phone that have install FC40 software. It comes with its own built in DJI

designed smart camera with 720p/30fps HD video support, and iOS or Android app control. Using a 2.4G Wi-Fi connection, it provides a full FPV experience at up to 100m.[8] It's the ideal choice for those getting started with aerial cinematography. The software will be downloaded at Google Play to connect with the camera. The software will function when the smart phone and the camera were connected through the Wi-Fi application.

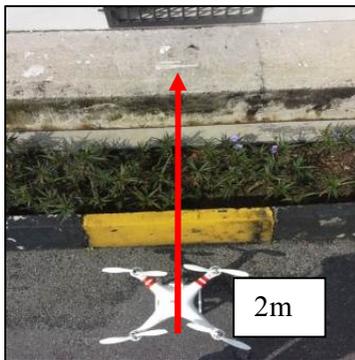
Fig. 2. Distance between UAV and building

Rigorous planning prior flight made to avoid things that are not expected to determine the distance between UAV and building must be less or equal to 2m [9] (Fig. 2). The direction of UAV line of flight in vertically [10] as shows in Fig. 3. The direction of flight starting from the bottom moves upward until the top of the building or at the roof and moves to the right side and slowly downward until reaches the ground. This steps repeat until the end of the building.

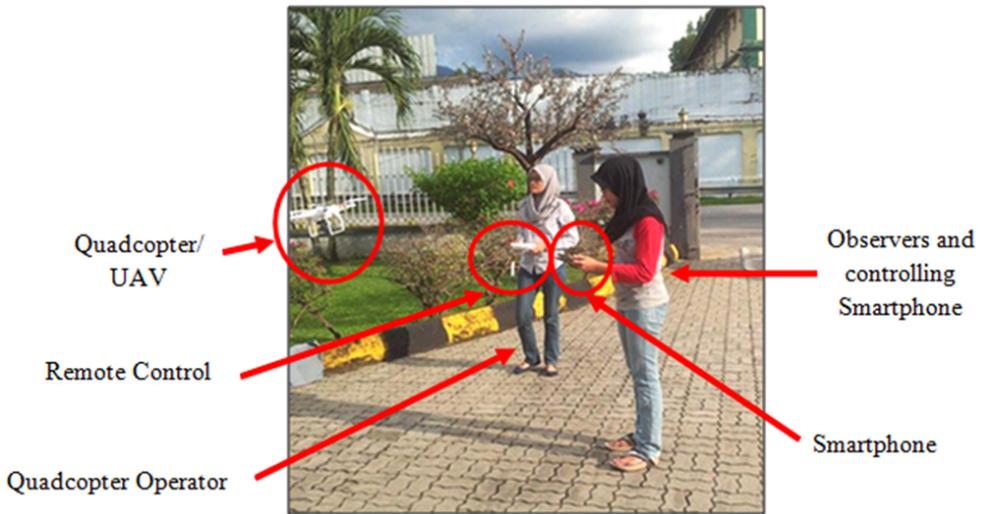
Fig. 4. System setup and Data Collection

Recording image and video from UAV camera is the method of collecting data. Because of the museum is bigger, the study divided the data collection into 3 phase. There are right side, front and left side. To conduct this research, at least need 2 persons involve while flying the UAV. One of them will control the remote of UAV and another one person need to monitor the smartphone and give the direction to the controller. There are 26 videos taken as the data for this research to show the whole building and to analysis the video.

Table 1 shows total number of data collecting on site and Fig. 4 shows the system were setup and data collection conducted.

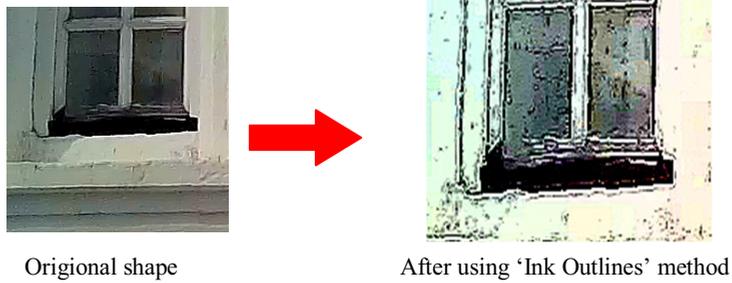
Fig. 5. Analysis for frame decayed

No.	Location & Type of Defect	Image Editing Method Used to Identify Defect	Image Defect	Zoom Image
1.	Right Side Frame decayed	Ink Outline Method

Through the image processing technique using Adobe Photoshop the total number of defects that occur can be identify. The defect has been choose for analysis is based on the repetition occurring. This stage will help to analysis the defect in different way from image processing that just zoom the image. Adobe Photoshop has been use to shows clearly the defect occur. Fig. 5 shows the image editing technique using 'Ink Outlines' method for frame decayed. The black color at the image after editing provide an indicator of broken or missing frame.

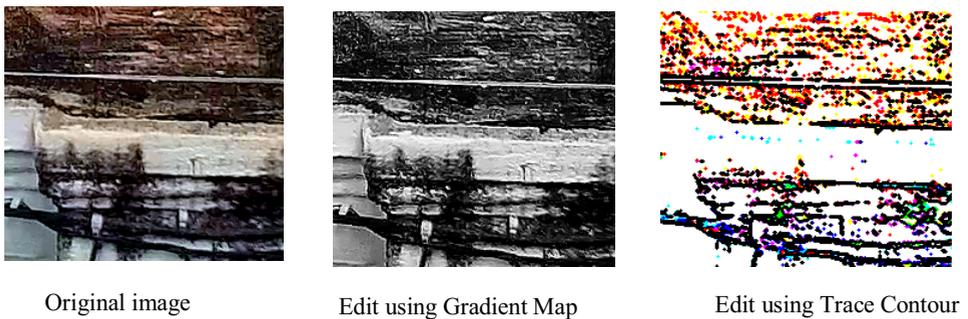
Fig. 6. Analysis for fungus.

2.	Front Side Fungus	Trace Contour Method

Fig. 6 show defect of fungus that occur at the front side of the building. For this defect, the research use Gradient Map and Trace Contour to make the defect shown clearly. It need couple of editing because of the first editing do not get excellent result and the image with colored dots representing fungus on the surface of the building. Fig. 7 show defect of gutters rusted and rotted. By using Brush Strokes Accented Edges, the rusted and rotted part visible clearly and the circle represent the defect.

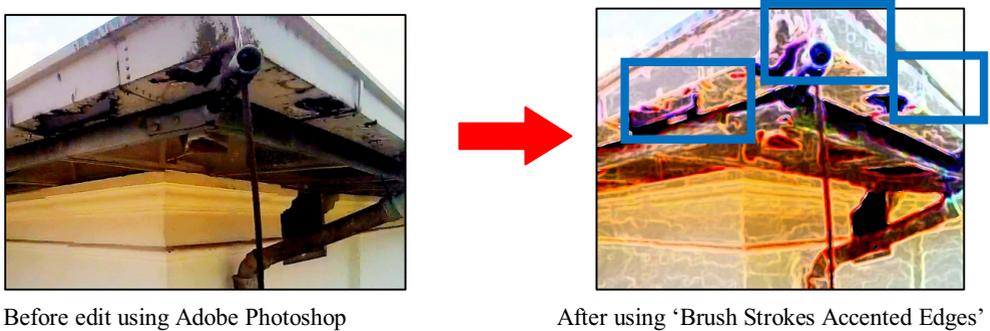
Fig. 7. Analysis for gutter rusted and rotted.

3.	Left Side Gutter rusted and rotted	Trace Contour Method

During the process of improvement of images, more than one an editing process to ensure that all the effects of the defect becomes clearer. For example, the process of brush strokes is more suitable to improve the image of the line as the image of the gutter.
