Impact of Agricultural Engineering Practices on Farm Management: A Case Study of Gharo Model Farm

Imran Arshad^{1*}, Omair Farooqui², Wajiha Ali³

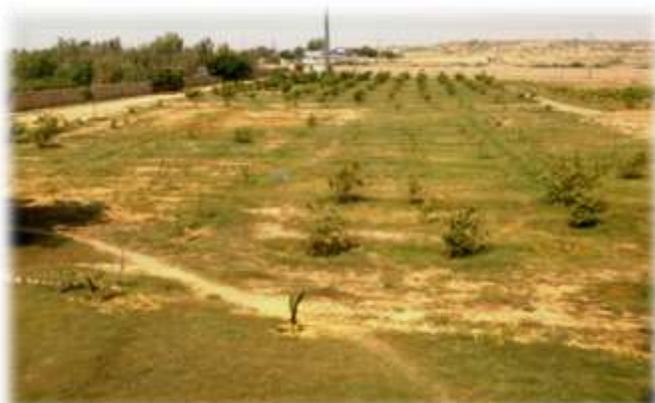
During initial survey it was observed that the topographic condition of the farm was varying due to uneven slopes. The soil condition was found poor due to the less water retention, uneven slopes, and poor land leveling. A lot of extra grass and weeds were grown throughout the land as described in Figure 1.

Fig. 1. Top view of gharo model farm showing extra grass grown around the guava and sapota plots.

Initially on guava and sapota plants traditional and cultural operations were performed. In the preliminary step weed and extra grass removal operation had been started. Tractor with cultivator implement had been used for the weed and extra grass removal operation. The average depth of cultivator was about 1 - 1.5 ft and the weeds and extra grass removal work had been completed in total 4 operations per acre. After the completion of operation the grass and weeds left on the land for natural sun drying. Two days later the weeds and extra grass were fully sun dried and had been cleaned (hand-picked) manually by labor.

After the cleaning operation land was leveled by a tractor with rear blade throughout the guava and sapota plots. With the objective of quick irrigation application to the plants, the water channelling operation had been done with the help of tractor and channel maker implement respectively. The basins of plants were prepared manually by local laborer accordingly.

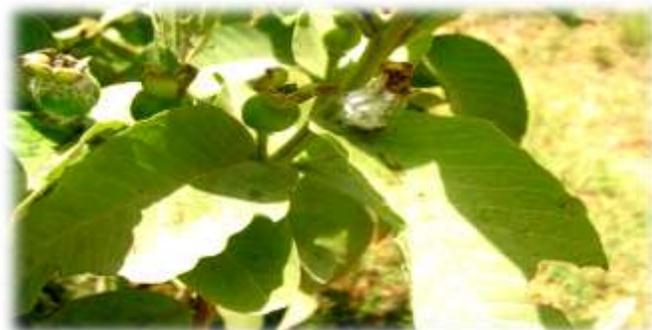
The survey also revealed that there was a serious attack of mealy bug on the small fruits of guava and mild attack on sapota and rodent holes were also noticed. Furthermore, in most of the guava plants termites (White ants) were also found. Leaves and branches were found infected with mealy bugs (Figure 2) and in roots portion with termites (White ants) as described in Figure 3.

Fig. 2. Mealy bug attack on Guava fruits.

In initial survey it was noticed that guava and sapota plants were badly affected by mealy bugs and termites therefore; two operations of pesticides via spraying and flooding were applied to the plants in order to control mealy bugs and termites.

A liquid chemical (Chlorpyrifos) with market name Lorsban 40EC was given to the plots in such way that 1 liter/acre was flooded with irrigation water to control termites and 150 ml / 100 liter of water was sprayed on the plants leaves and branches to control mealy bugs activity respectively. After the twice application of pesticides on to the plants it had been noticed that overall mealy bugs and termites appearance was 95% reduced.

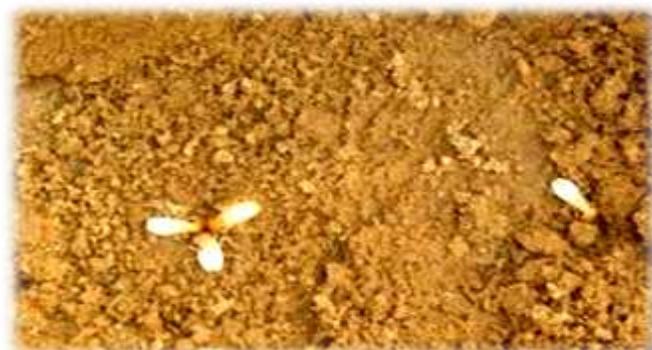
Fig. 3. White ants (Termites found during pest scouting)

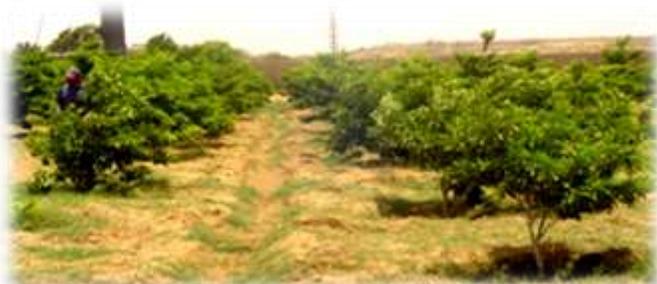
The farm was facing a serious problem of water scarcity as there was no canal water available and the only source for irrigation was groundwater. Extra grass and weeds covered all the basins and water channels (Figure 4) due to

which water distribution was very much affected and the time required to fill the basins was also exceeded.

Fig. 4. Weeds and extra grass grown in water channel and basins.

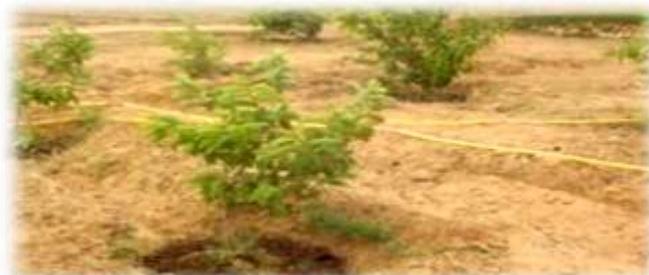
The organic matter content was found less in soil and which might have negatively affected fertility therefore; 30 - 40 kg of organic manure was given to each guava and sapota plants. The fallow basins within the plots were filled with baby plants of guava and sapota purchased from the nursery near Malir Halt, Karachi (Figure 5).

Fig. 5. Organic manure given to guava plants.

30 - 40 kg of organic manure was given to each guava and sapota plants respectively. Due to manuring the water retention capacity within the soil was increased. The farm staff asked to apply organic manure to the fruit crops once in a year before the arrival of winter season as it would be beneficial for the soil and plants.

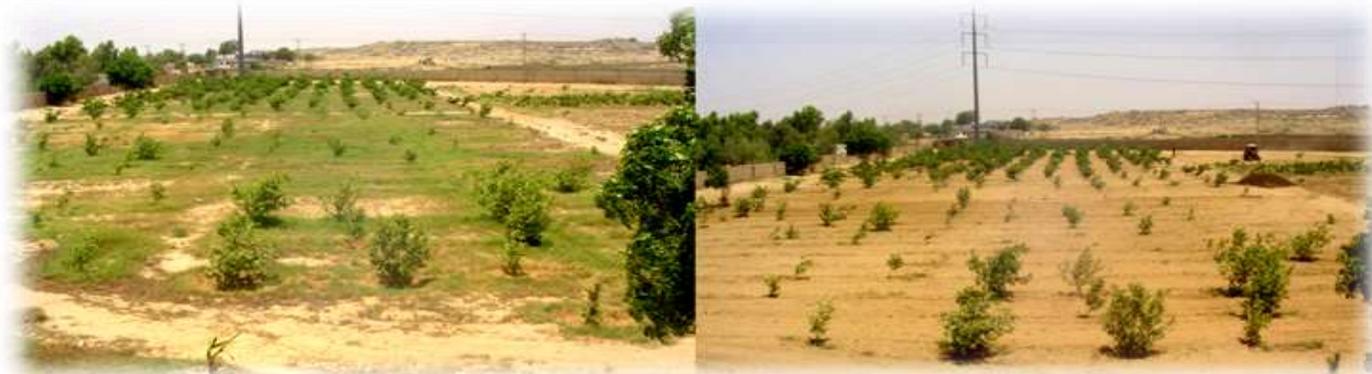
A uniform look among plantation has been developed due to cultural practices and land leveling operation. Due to proper water channelling time to fill the irrigation water in to the basins also decreased up to some extent. As the extra grass grown on the guava and sapota plots belonged to self growing grass family therefore it was hard to completely remove it however cultural practices were continued to overcome the grass growth. Figure 6 described the uniformity among plants before and after rehabilitation.

Fig. 6. Pictorial view of Gharo Model Farm before (left) and after (right) rehabilitation work.
